**Ponding Test Results
Seepage and Total Losses,
Secondary Canals 13, 16, and 29
Donna Irrigation District
Hidalgo County No. 1**

March 30, 2004

Eric Leigh and Guy Fipps,¹ P.E.

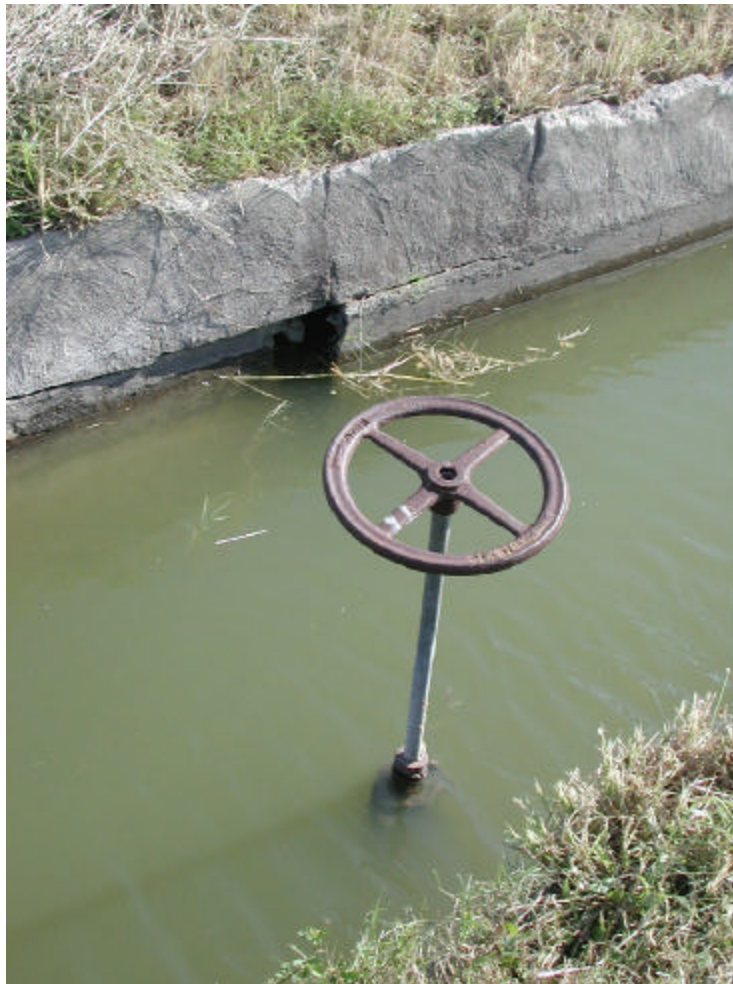
DO1 was a seepage loss tests. However, test segments DO2 and DO3 contained turnout gates that may have contributed to measured losses; thus, the total losses were measured (Fig. 1).

Figure 1. Large cracks and turnout gates shown above contribute to higher total losses of canal segments.

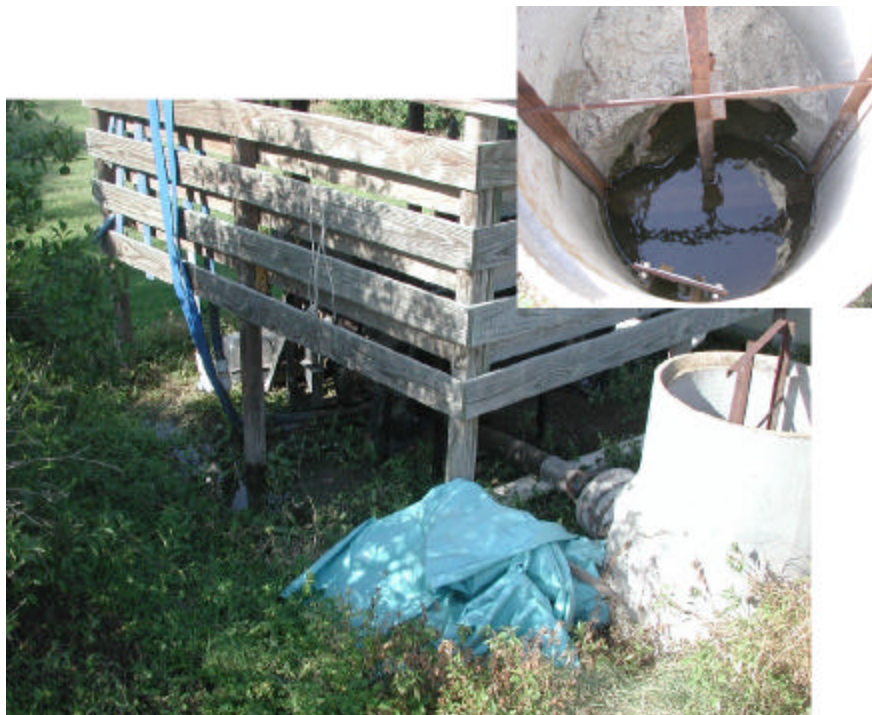
- The average seepage loss rate measured for Test Segment DO1 was 1.68 gal/ft²/day.
- Test Segment DO2 had four turnout gates (one turnout gate verified as leaking) and a 2 inch PVC pipeline may have contributed to the total loss rate of 2.18 gal/ft²/day.
- Test Segment DO3 had three turnout gates (unable to be verified as leaking) that may have contributed to the total loss rate of 2.71 gal/ft²/day.

- Test segment DO1 did not contain valves or gates within the canal; thus, the seepage rate was measured.
- Test segment DO2 and DO3 contained several leaking turnout gates (Fig. 5); thus, we classify this as a total loss test since the gates contributed to the measured losses.

Figure 5. A leaking turnout gate leak found in Test Segment DO2.

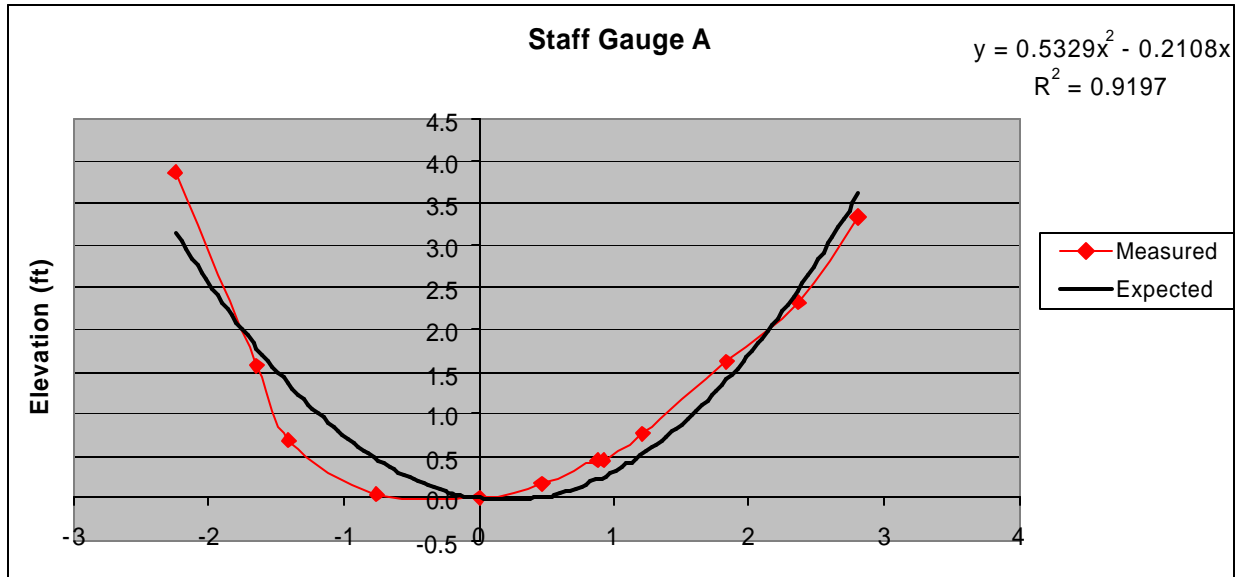
Figure 8. Cross-section of Staff Gauge A, DO2.

Figure 9. Shows test segment DO2 with serious structural problems that has been repaired many times over, and since has change the shape (see Fig. 8).
